MD State Highway 219 Culvert Assessment Project 2012

Prepared for the Policy and Review Board
Meeting, 7/23/2012

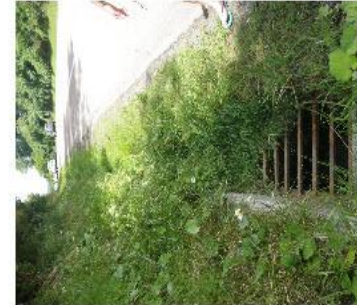
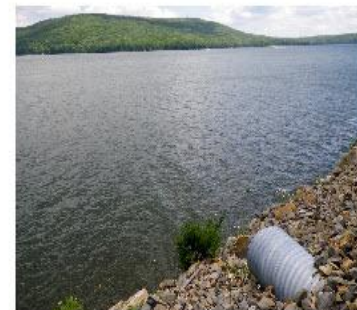
Map Information Example

SC035
Material: Metal
Diameter: 24"
Number of sources: 3
Condition: 1
Impact: No
Priority: 1
Return:

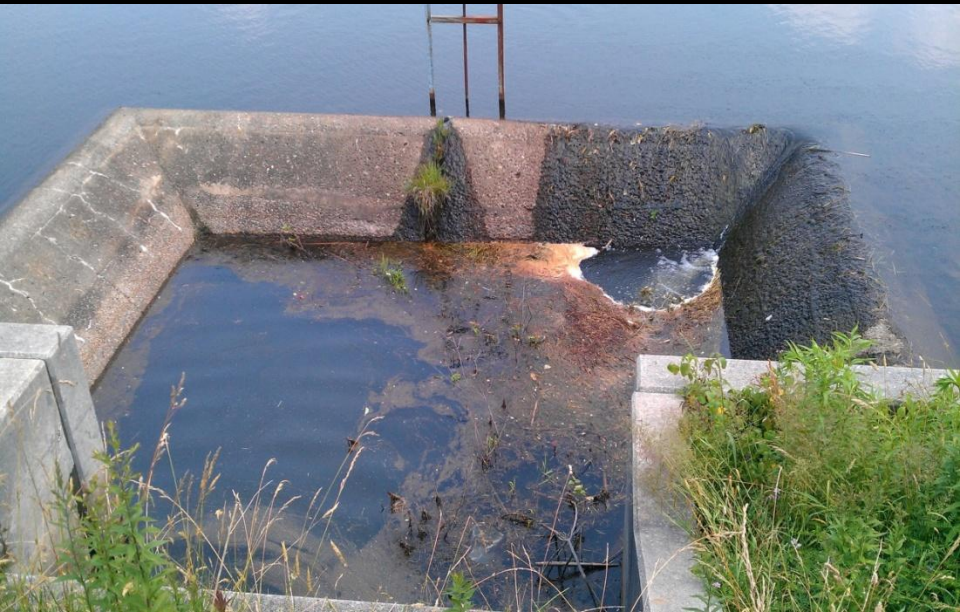
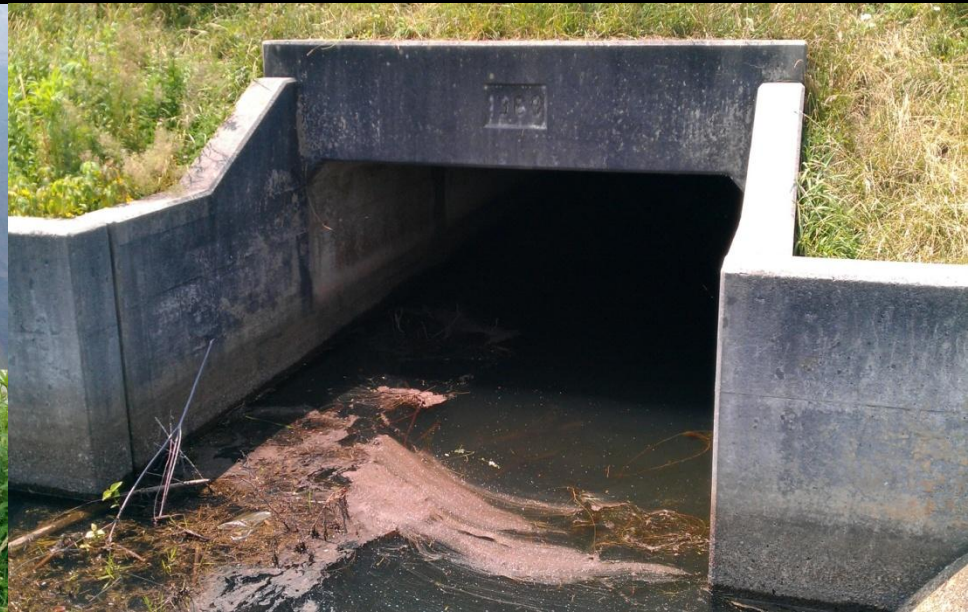
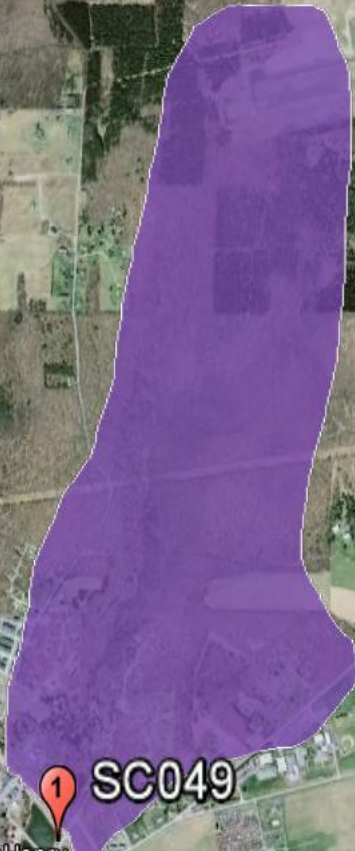
#2 – SC049

- Wooded area north of Mosser Road on east side drains into Marsh Run Cove on west side
- Potential for high nutrients from residential and agricultural areas upstream

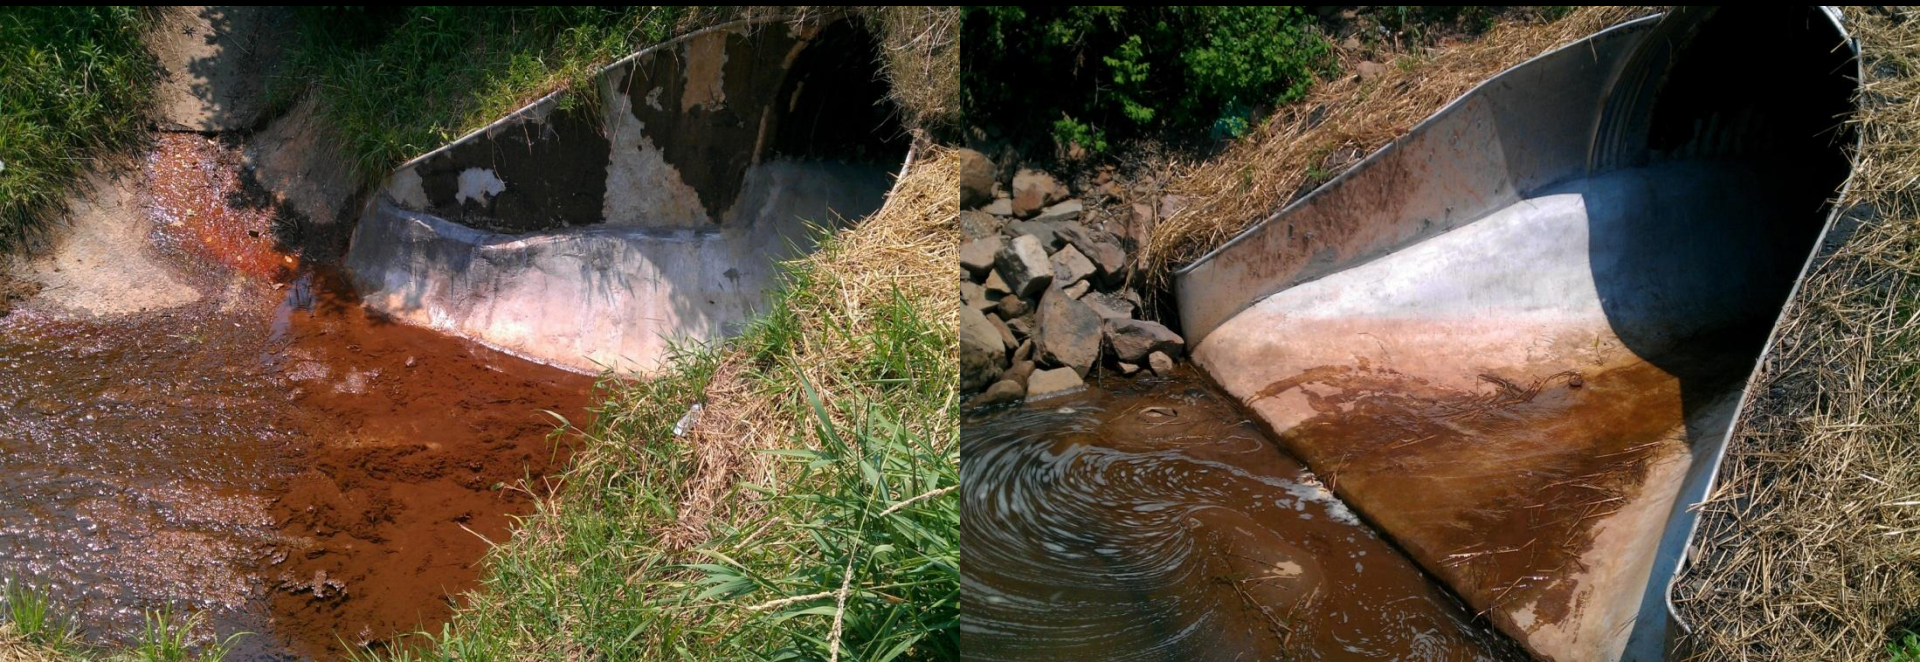
#1 – SC048

- Drains extensive area, including many roads, residential areas, part of Garrett College campus including new construction area, RV Park, and the entire fairgrounds and their new 600 car asphalted parking lot
- Water appears incredibly polluted
