# **Deep Creek Lake Submerged Aquatic Vegetation Survey**

Report of Summer 2010 Survey Activity

February 4, 2011

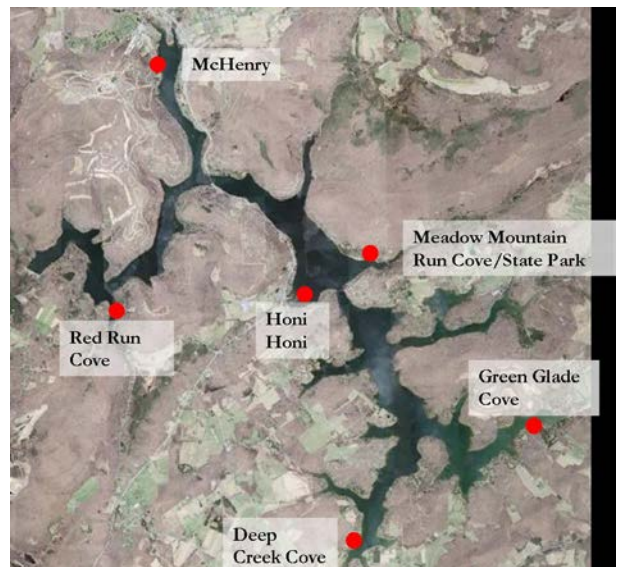
Figure 1. Deep Creek Lake with transect locations.

In June 2010 RAS staff, accompanied by local SAV experts, identified six areas to survey throughout the lake. These locations include an area near the town of McHenry (-79.35787, 39.55087), Green Glade Cove (-79.26206, 39.47844), Red Run Cove (-79.3711, 39.49977), Meadow Mountain Run Cove (-79.30334, 39.51182), Deep Creek Cove (-79.30904, 39.45368), and near the Honi Honi Bar and Restaurant in Thayersville (-79.32091, 39.50485) (Figure 1). At this time, three informal transects were surveyed and sampled at McHenry, Meadow Mountain Run Cove, and Deep Creek Cove. The purpose of these transects was to establish the types of SAV present, the approximate size of the SAV beds, and the depths to which the SAV beds extend. Later in the summer, two full surveys were completed at the six locations chosen. The first survey took place August 4-5, 2010; the second took place September 15-16, 2010. Methods were the same for each sampling event.
